Manhole Inspection Summary

Manhole # S13QQ_002MH

Insp Date: **9/17/07 4:04 PM**

Location Address: **DUKELAND ST**

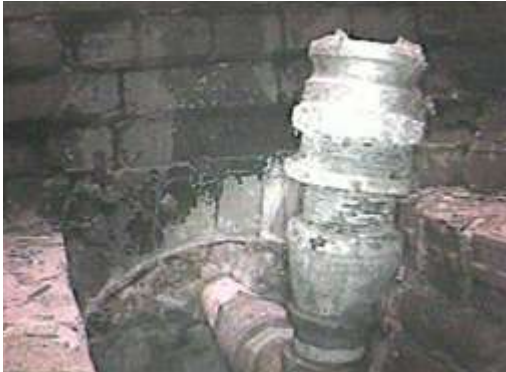
UNKNOWN

Comments **UNKOWN VALVE INSIDE MH./ OLD 18 INCH LINES WITH NEW 8 INCH PVC AND CONCRETE SURROUND**

UNKOWN VALVE IN MH

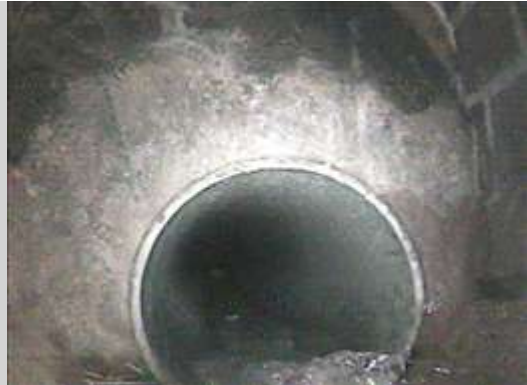
12 O'Clock Outflow

8 in. Circular Gravity Sewer
Pipe Out @ 12 O'Clock

Invert Depth: **9.01** (ft.) Flow Characteristics: **Slow**

Infiltration: **None** Pipe Seal Cond: **Sound**

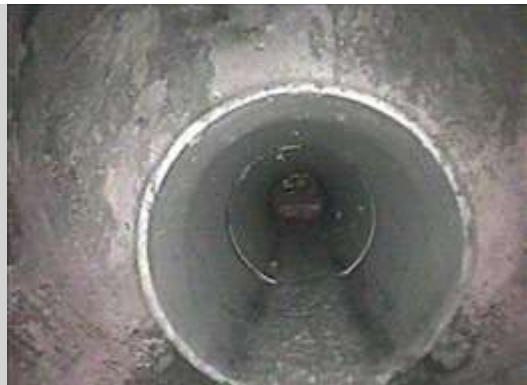
7 O'Clock Inflow

8 in. Circular Gravity Sewer
Pipe In @ 7 O'Clock

Invert Depth: **8.81** (ft.) Flow Characteristics: **Slow**

Infiltration: **None** Pipe Seal Cond: **Sound**
